MEMORANDUM

To:	File
From:	Eron Dodak, David Livermore, Integral Consulting Inc.; Rob Webb, Dalton, Olmsted & Fuglevand, Inc.
Date:	March 8, 2022
Subject:	City of Portland Pressure Sewer Main Location and Revised Core Location Buffer
Project No.:	CF167

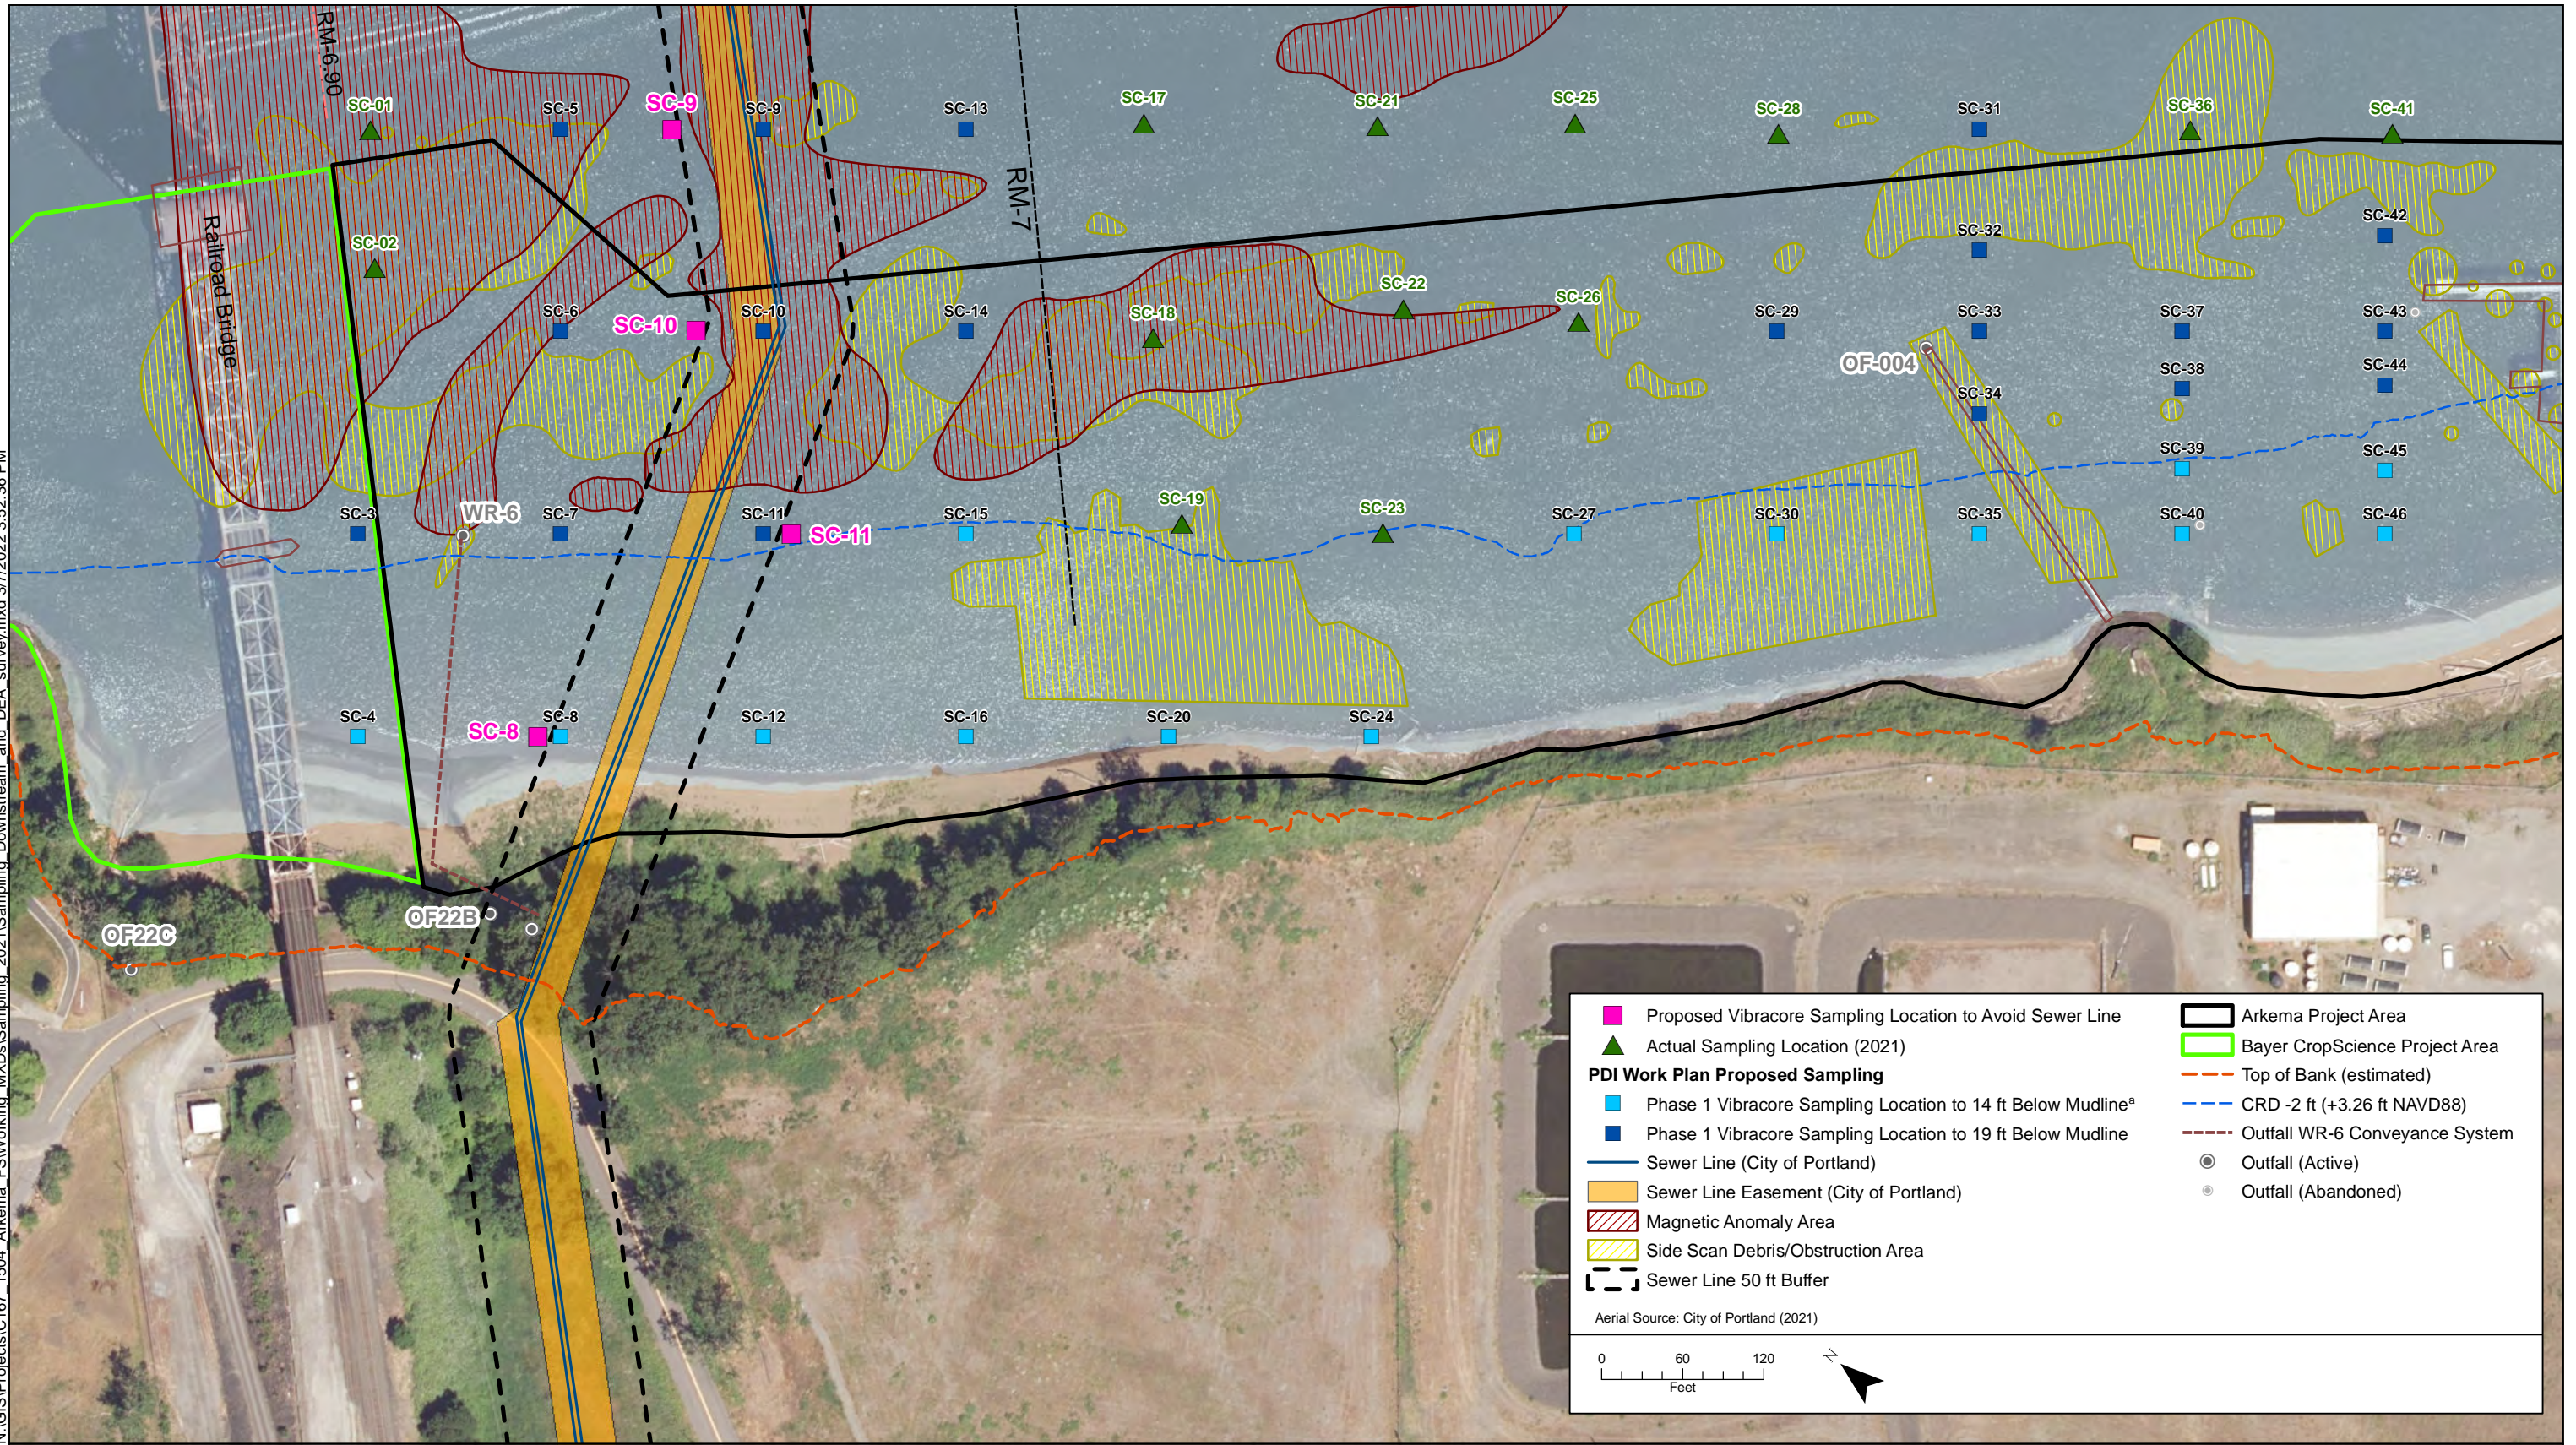
Figure 1a depicts features identified by the side-scan sonar and magnetometer surveys in the downstream portion of SMA RM7Wa. The side-scan sonar identified various known features including the rock cover for Outfall 004, a piling field along the shoreline, and various other objects in the RM7Wa. The magnetometer also identified various objects including the likely pressure sewer main, where it bends and crosses the channel, and other metallic objects in the area. The magnetometer survey could not be conducted shoreward of the -2 ft Columbia River Datum contour line because of lack of ability to deploy the instrumentation in shallow water areas.

Various geophysical and bathymetric survey methods were utilized to identify the location of the City pressure sewer in the area of RM7Wa. The location of the pressure sewer main is shown on Figures 1a and 1b.

Based on the precision of the magnetometer data, Integral and DOF are proposing a 100-ft corridor (50 ft on either side of the mapped sewer line) as a no coring buffer area for use in completing the PDI in this portion of SMA RM7Wa. Figures 1a and 1b show the buffer area and the EPA-approved proposed core locations within the buffer area (blue squares). Specifically, the original proposed locations for SC-8, SC-9, SC-10, and SC-11 fall within the no coring buffer area. Integral and DOF propose moving the locations of each of these cores to immediately outside the buffer area as shown as pink squares on Figure 1b. No other core locations would be affected by the proposed buffer. This buffer would apply to any future subsurface (i.e., greater than 1 ft below mudline) work proposed in subsequent phases of investigation or remediation. Adequate and appropriate buffers will need to be similarly developed for any future sediment remediation work within the vicinity of the pressure sewer main.

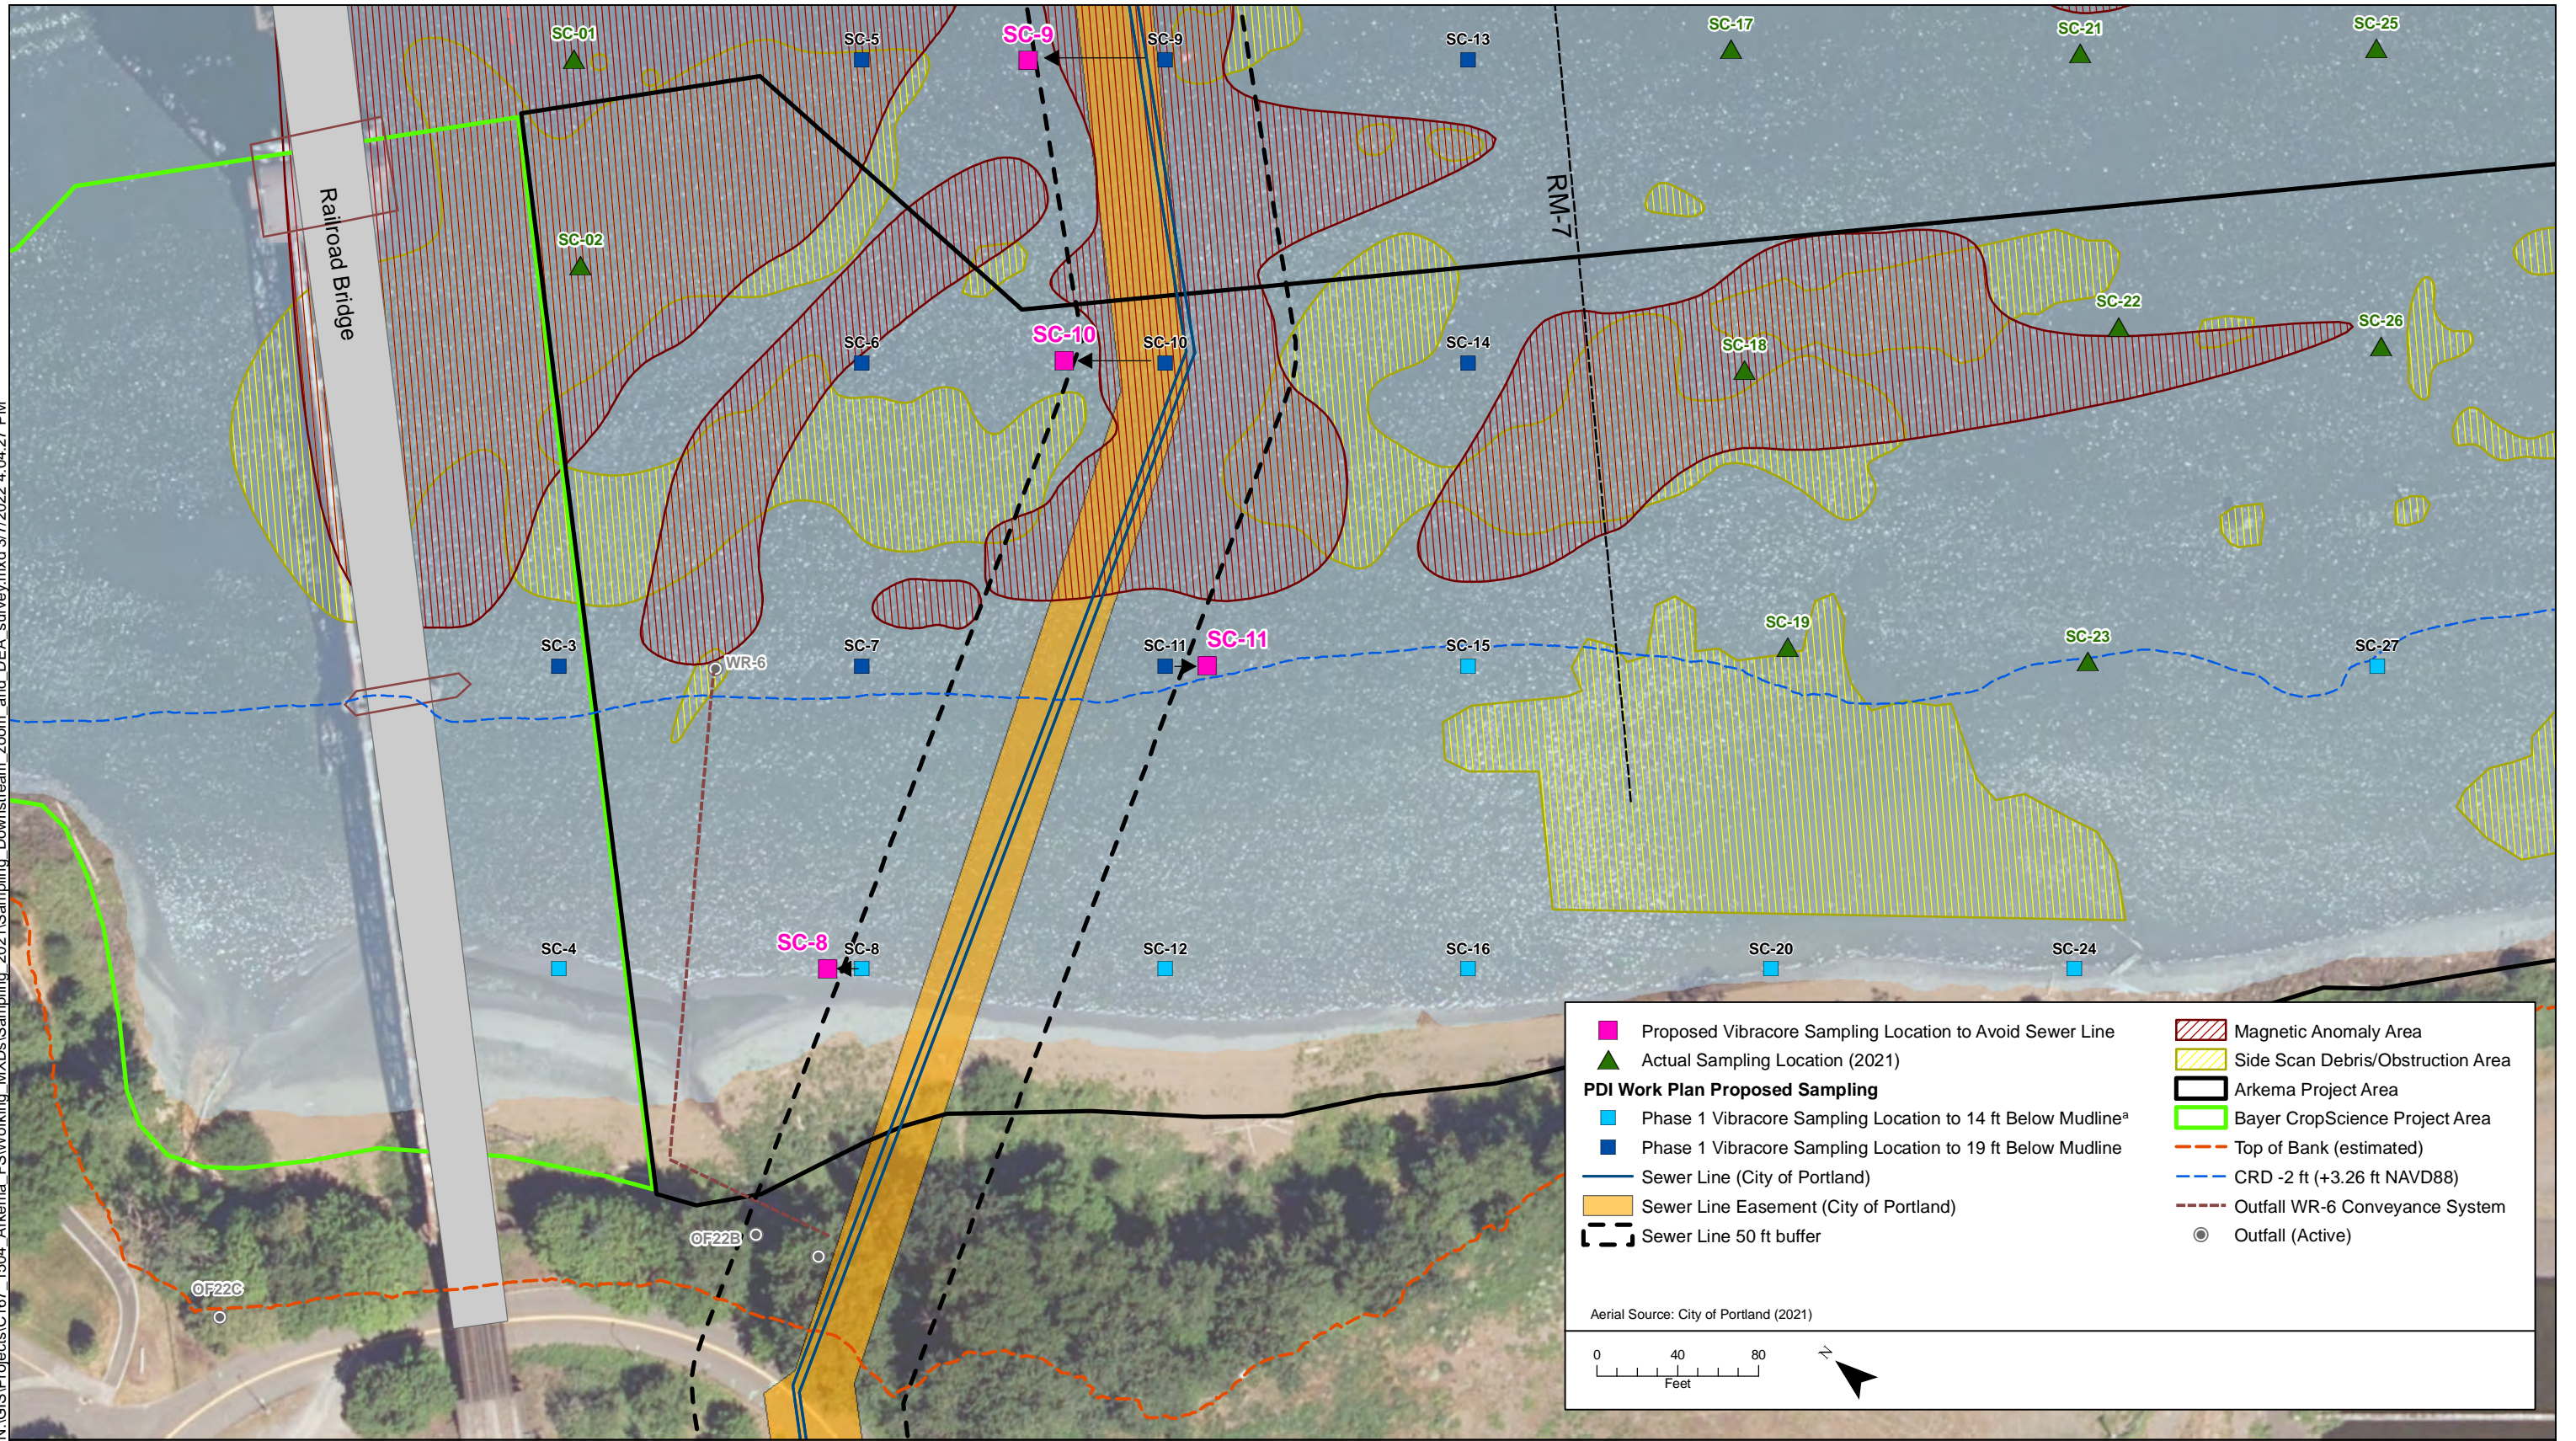
Figure 1b.

Figure 1b is a close-up of the downstream portion of the investigation area showing both magnetic anomalies and side-scan area identified “obstructions.” Figure 1b also shows the location of the pressure sewer main based on maps provided by the City. In addition, surveyed points on the pressure sewer main where it was located in the upland and beach areas are shown on this figure. Note that the upland survey points align closely with the pressure sewer main shown in green. Based on this analysis, the location of the pressure sewer main has been adequately identified to continue investigation in SMA RM7Wa, subject to a buffer area as proposed in the following section.
